ALEXANDER SCHLEICHER SEGELFLUGZEUGBAU

ASK 21 B

Maintenance Manual Repair Manual

Model:	ASK 21 B
Serial Number:	21953
Registration:	VH-GTY
Data Sheet No.:	EASA.A.221
Issue:	15.06.2018

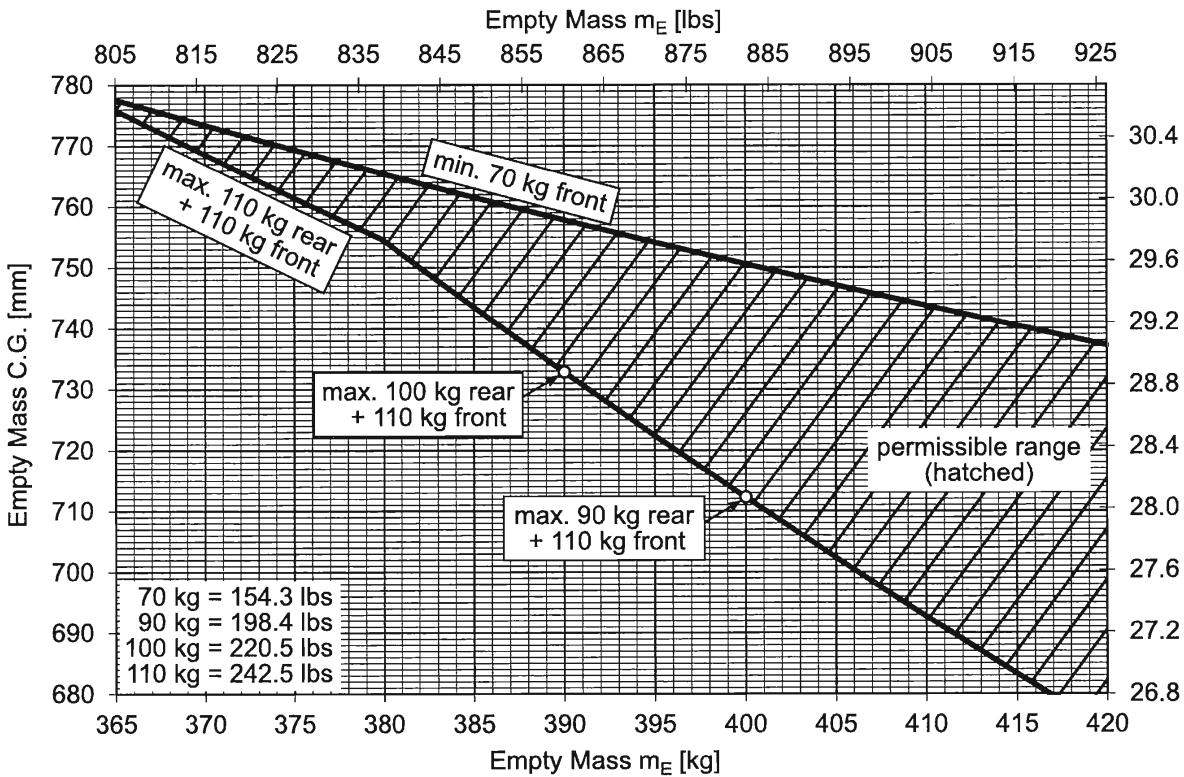
Only the hatched area of the diagram is the permissible empty weight c.g. range. If necessary, **permanently fixed ballast** has to be fitted to bring the glider into the permissible range of the diagram.

Fig. 6.4-1 Diagram of Empty Mass C.G. Position
[kg] [lb]

Section 6.7 provides necessary data on useful loads so that the "Mass and Balance Form" can be filled in correctly; and the diagram Fig. 6.4-1 gives the necessary information to comply with the C.G. limits.

With Fig. 6.4-1, this results in:
